SUPPORTING FIGURES FOR INVOICE

Robert Pye FIOC (Institute of Carpenters) BADA (West Dean) Diploma

Beech Tree Workshops, Tuxwell Farm, Spaxton, Bridgwater, Somerset TA5 IDF

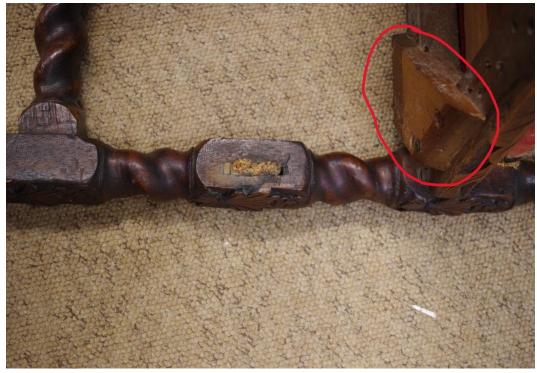
Fig,1 Front Blocks (pair).

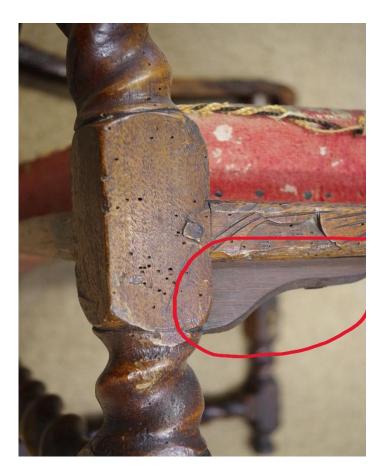
Fig 2, Corner block (back) you can see the woodworm is the back leg.

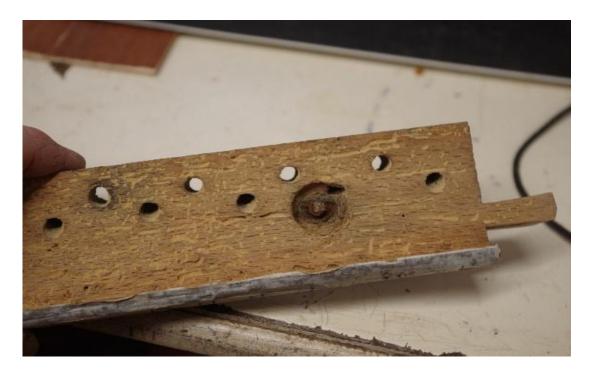
Fig 3, the remains of one of the, burried screws. More signs of worm.

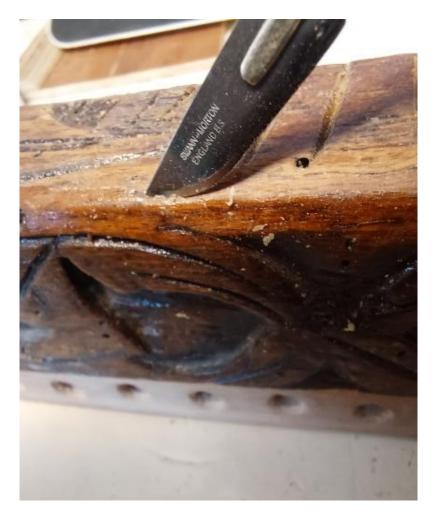
Fig 5, Scraping off the surface, the hardened consolidator off

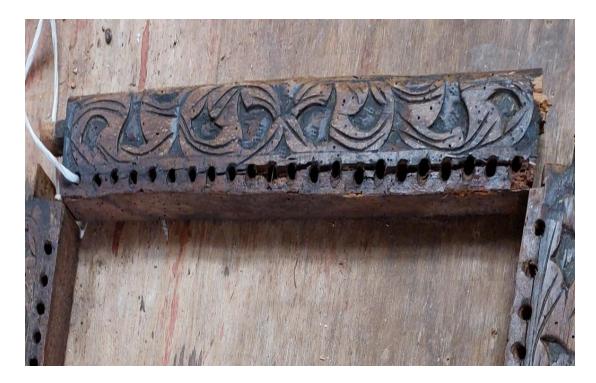
Fig 6, One of the seat rails with split down the line of cane holes due to the wood worm.

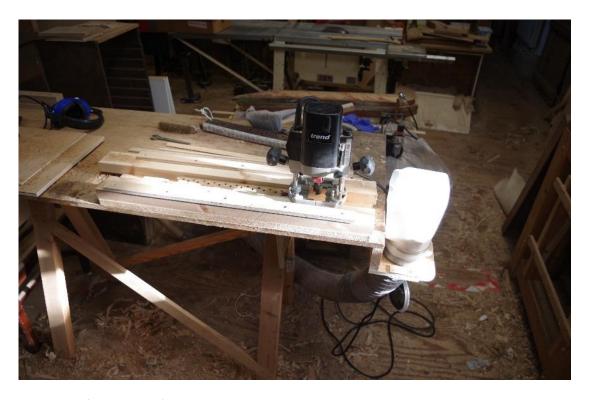
Fig 7, Jig A for routeing (gutting the seat rails & the leading edges later.

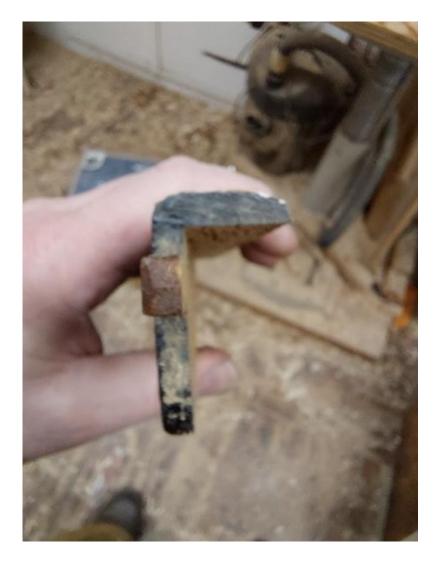
Fig 8, the remaining 'L' section of the seat frame.

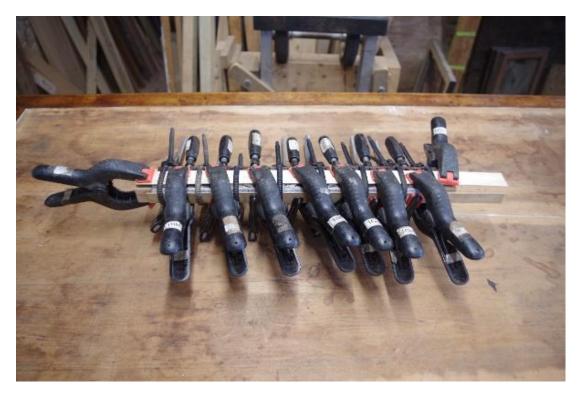
Fig 9, One of the seat rails with the replacement beech

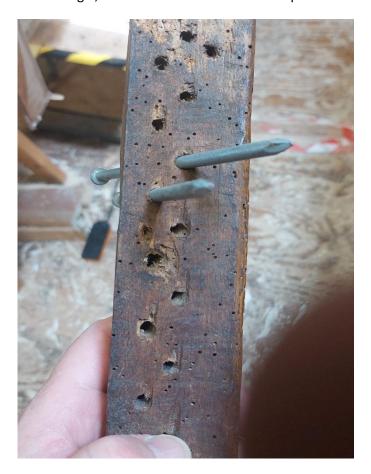
Fig 10, The offset holes on the seat frame.

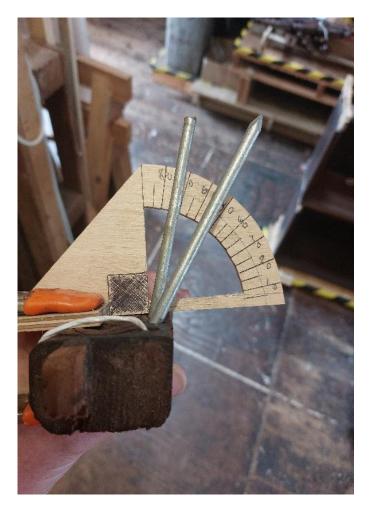
Fig 11, showing the 20degree difference.

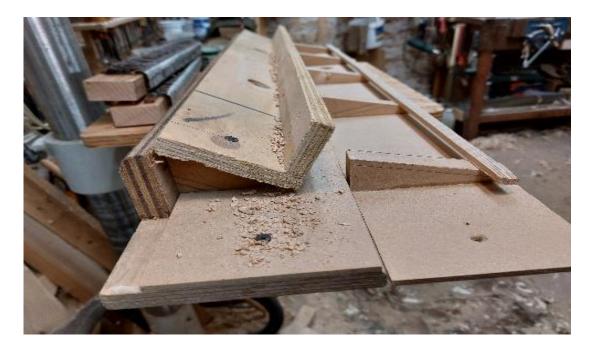
Fig 12, The Jig B & C for the drilling of the holes in the seat rails, & bask rails, Note the different angle with interchangeable angled boards.

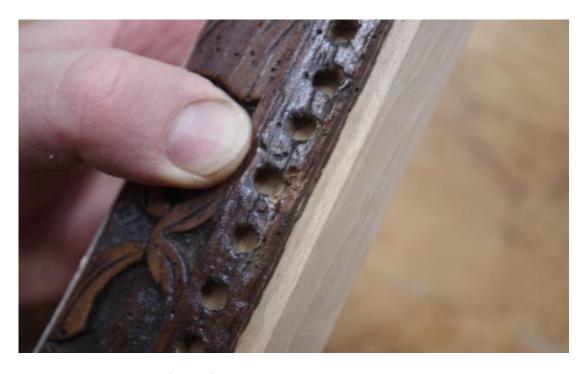
Fig 13 the leading edge of one of the seat rails. note the worm breaking through.

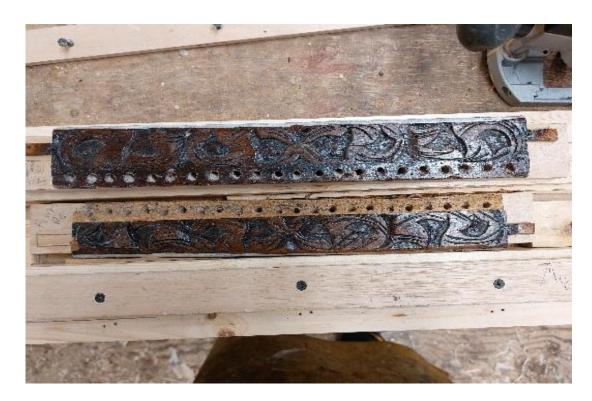
Fig 14, the routeing of the old edge. In Jig a (fig 6).

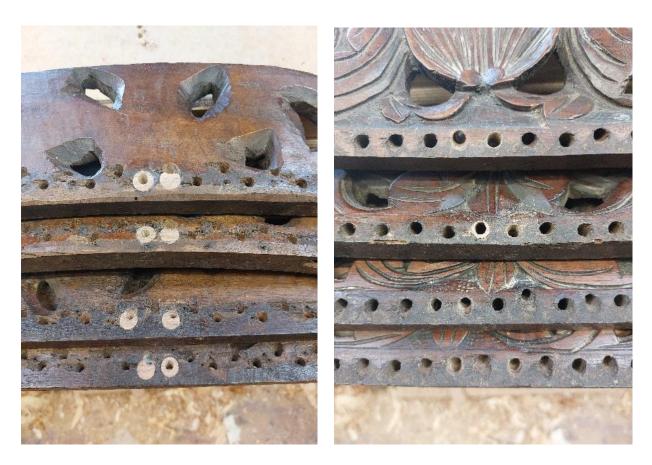
Fig 15 & 16, The pluged and drilled holes on the back carved , cresting rail and the bottom rail and the 2 sides of the back.

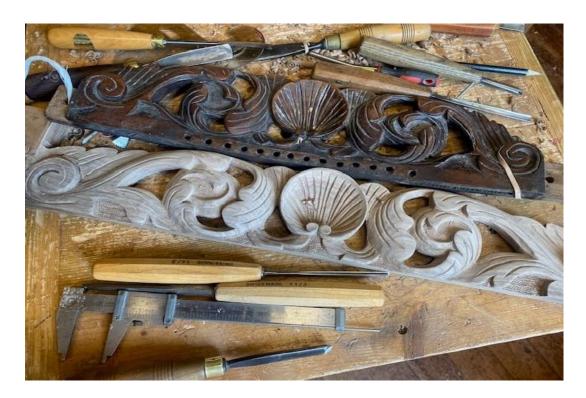
Fig 17, The new carved stretcher with the creating rail as a guide.

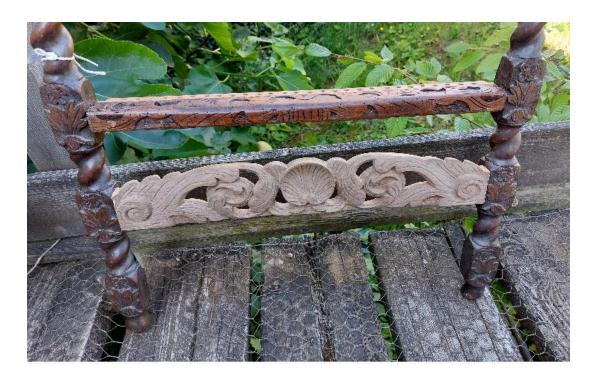
Fig 18, Stretcher in place.

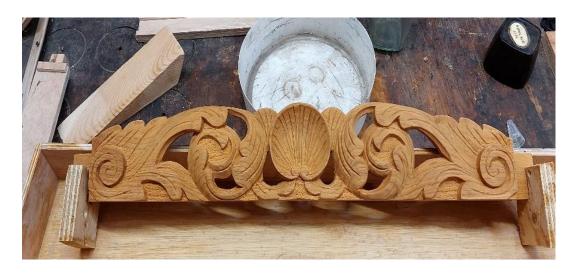
Fig 19, After bleaching with Nitric acid then neutralised with Acetic Acid and Oxalic acid.

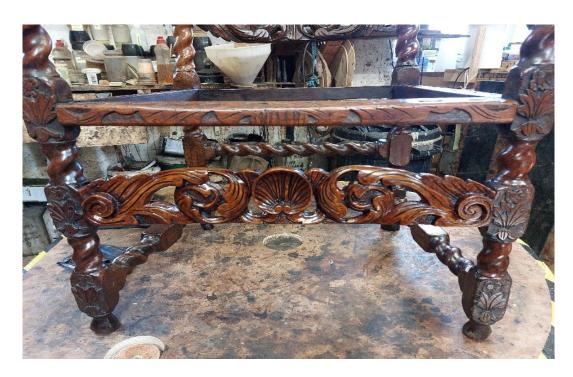
Fig 20, The Stretcher after colouring

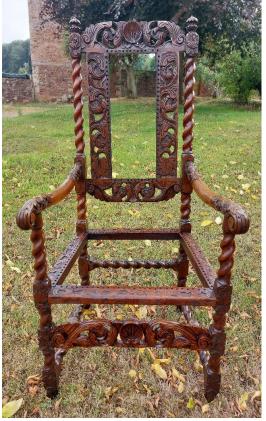
Fig 21 the chair before caning.

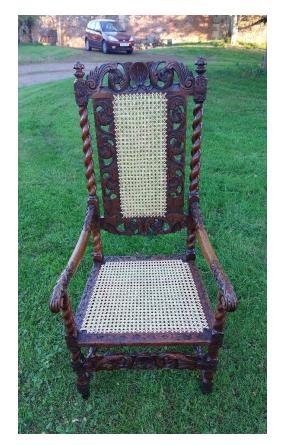
Fig 22 after caning

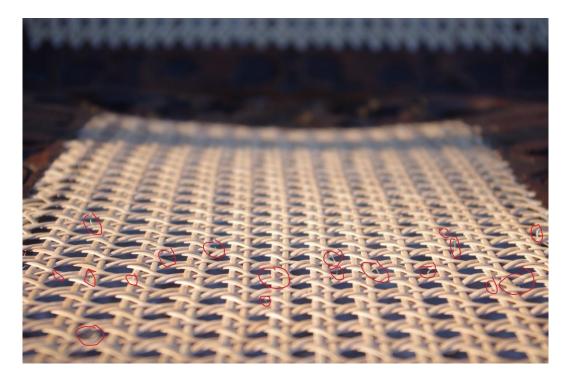
Fig 23 some of the loose ends

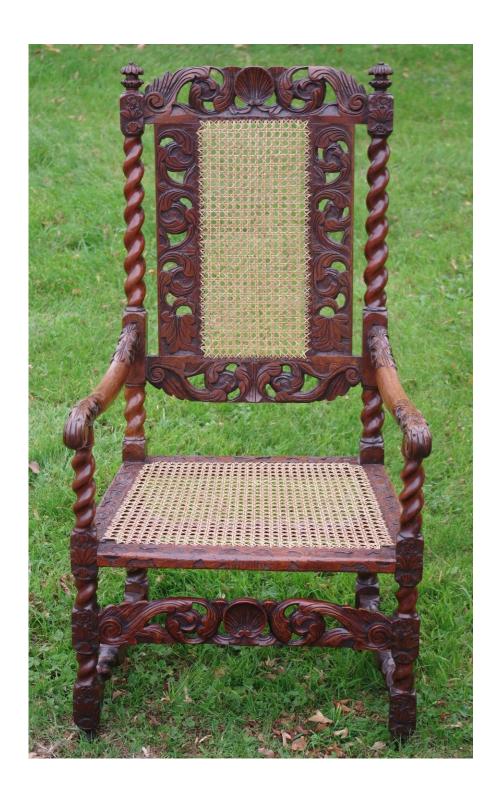
Fig 25, Finished chair with caning stained after losing the new look and hairy loose ends one the cane by flame.
